CALIFORNIA REGIONAL WATER QUALITY CONTROL BOARD - SAN DIEGO REGION WATERSHED MANAGEMENT PROGRAM

FACILITY INSPECTION REPORT

Ryland Homes of California, Inc. Serenada Site Murrieta, California

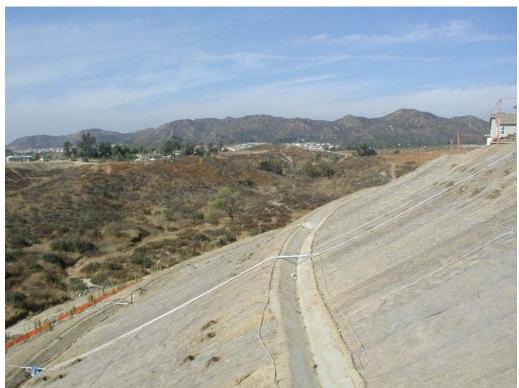
Photo No. 1 (P1010018.jpg), looks to the North from the Serenada site. Slopes are irrigated and have mats. Landscaping holes have been made in the upper portions of the mats for plants.

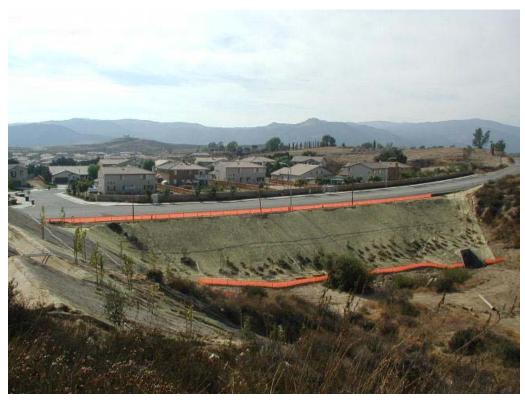
Photo No. 2 (P1010019.jpg), looks to the South from the Serenada site at Jackson Ave. Slopes are irrigated, have mats and landscaping has been planted. Orange silt fences run along the upper and lower portions of the slope.

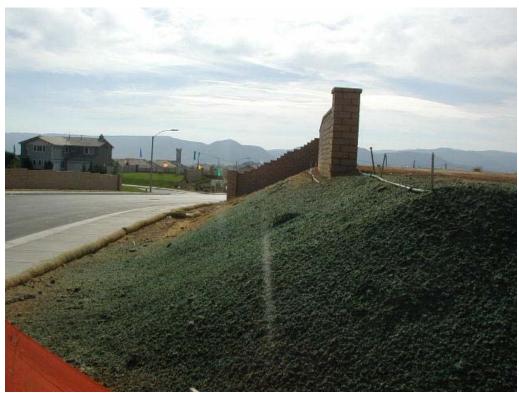
Photo No. 3 (P1010020.jpg), taken from Sarratoga Springs looking South along Eden Springs Way. Interior slopes have been sprayed, have fiber rolls along sidewalk perimeter and orange silt fences on the front perimeter of individual house pads. Streets are clean and free of sediment.

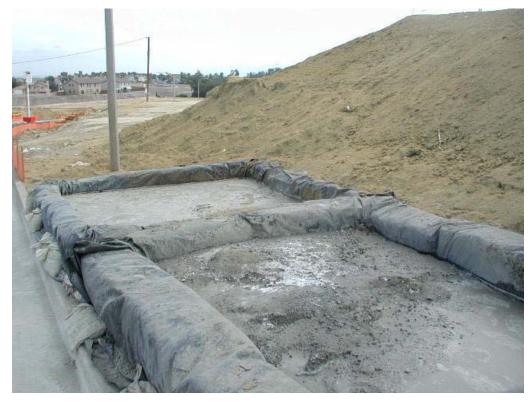
Photo No. 4 (P1010021.jpg), looking at the concrete washout area at Caliente Springs Avenue.
